DOT/FAA/AR-95/81

**Corrosion of Aluminum Alloys in the Presence of  
Fire-Retardant Aircraft Interior  
Materials**

October, 1995

Final Report

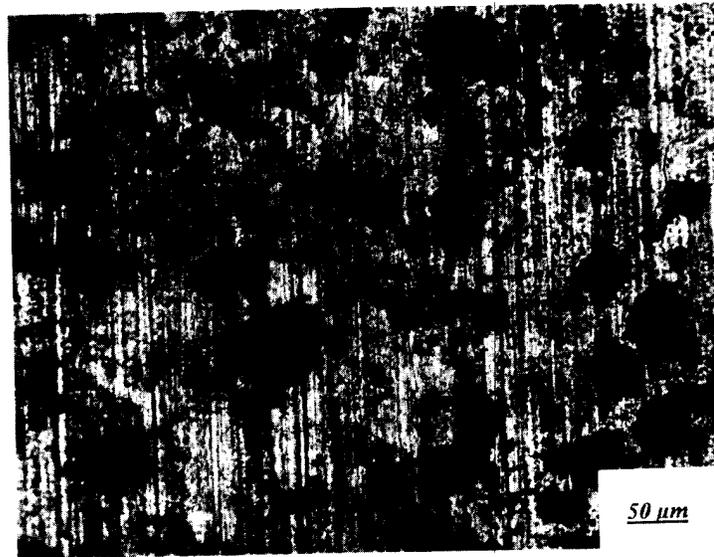
FIGURE 4. MICROGRAPH OF AL 7075-T6 WITH ULTRASUEDE, 100°F, 90% RH, 21 DAYS (SEVERE CORROSION, 100 POINTS)

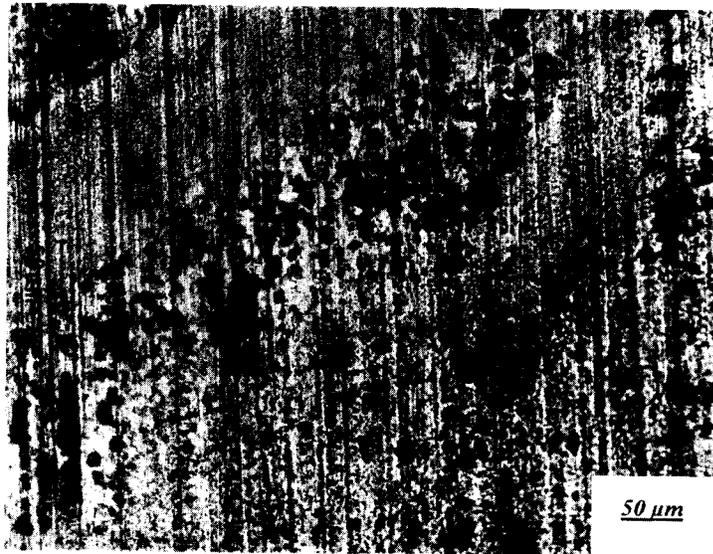
FIGURE 7. AL 2024-T3 WITH ULTRASUEDE, 100°F, 90% RH, 21 DAYS  
(50 POINTS)
